NIST NCSTAR 1-5A

Federal Building and Fire Safety Investigation of the World Trade Center Disaster

Visual Evidence, Damage Estimates, And Timeline Analysis

(Chapter 9 - Appendix C)

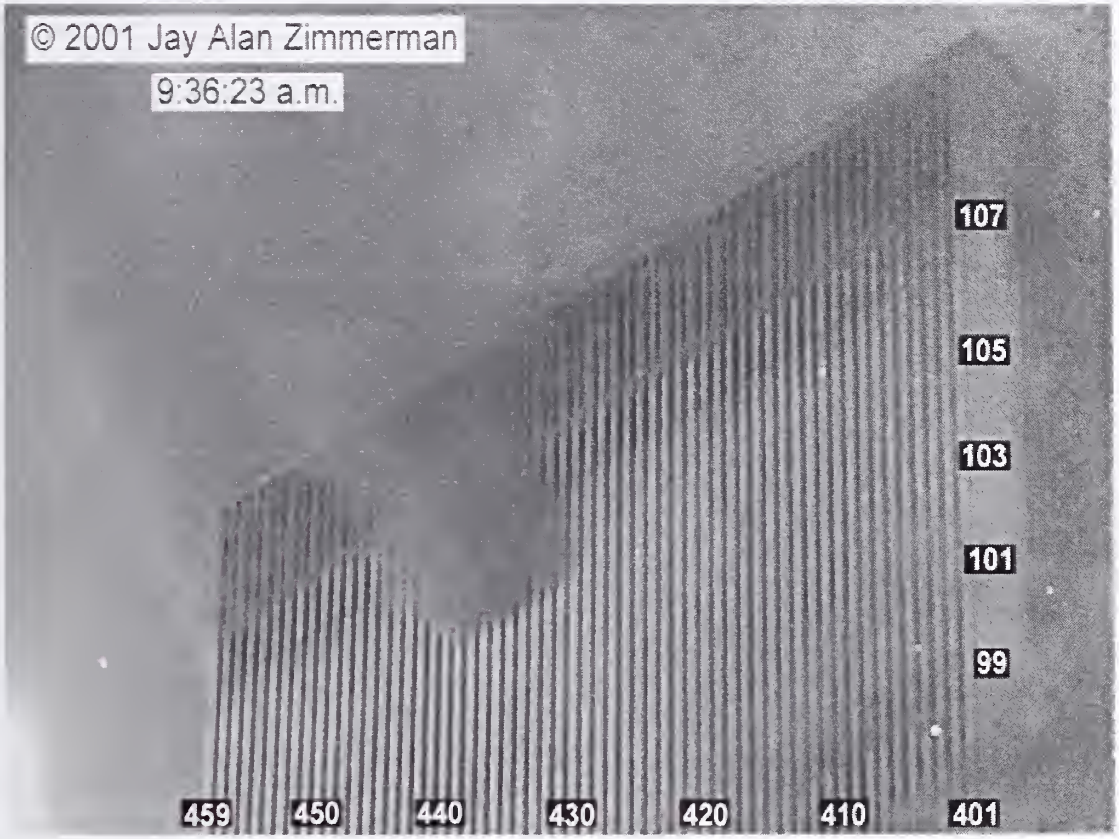
Clear close-up images of the fires on the south face of WTC 2 are limited between 9:30 a.m. and 9:38 a.m. Figure 9–54 shows a frame taken from a video of the upper portion of the south face at 9:36:23 a.m. It has been included because at this time the smoke on the face cleared sufficiently to observe that heavy smoke was coming from multiple windows, extending from roughly window 105-430 to window 105-438, on the 105th floor. This is another location where people may have broken open windows. This was the only location above the fire floors where smoke flow from open windows was evident on this face. In particular, no smoke was observed flowing from the upper mechanical equipment room floors.

Figure 9-54. This image is taken from a video shot from the southeast and shows the upper portion of the south face of WTC 2 at 9:36:23 a.m. The intensity levels have been adjusted, and column and floor numbers have been added.

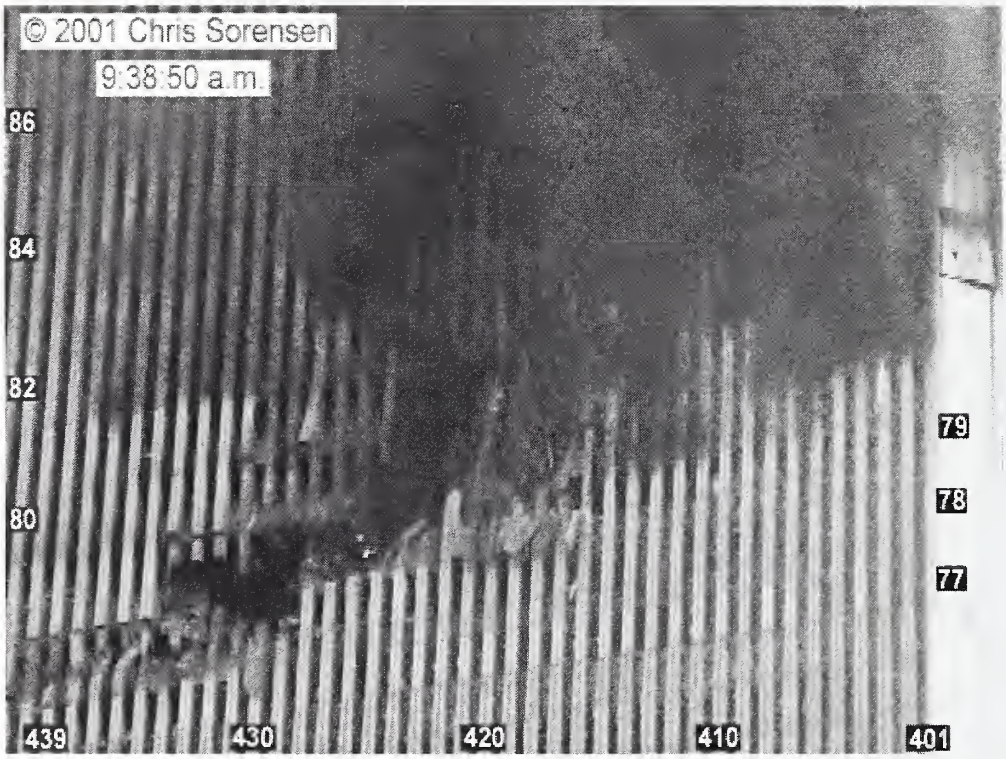
A video shows that heavy smoke began flowing from windows at the eastern edge of the south face on the 80th floor at 9:38:12 a.m. This smoke is visible coming from windows 80-401 to 80-408 in Figure 9–55, which shows a frame captured from a video recorded at 9:38:50 a.m. In the video, fire, which is visible inside windows 80-407 and 80-408, occasionally extended from these windows. The smoke coming from the 80th floor tended to hide the windows on the floors immediately above, but there were brief glimpses of a fire burning on the 83rd floor.

Comparison of Figure 9–55 with Figure 9–41, which was taken roughly 8½ min earlier, shows that changes in fire locations and intensities have taken place on the south face. In comparing the images it should be kept in mind that Figure 9–55 was shot from further east and, as a result, low intensity fires are likely to be hidden by columns. With this caveat in mind, it is clear that the large fire visible in windows 81-431 to 81-435 to the left of the aircraft impact cavity in Figure 9–41 has died down. In Figure 9–55

only a small spot fire is visible near the bottom of window 81-435. On the 79th floor, flames are no longer evident near window 79-426, but the fire has migrated to the east from this area, and burning is now visible in windows 79-408 to 79-410.

Figure 9-55. This image of the south face of WTC 2 was captured from a video recorded at 9:38:50 a.m. The intensity levels have been adjusted, and column and floor numbers have been added.

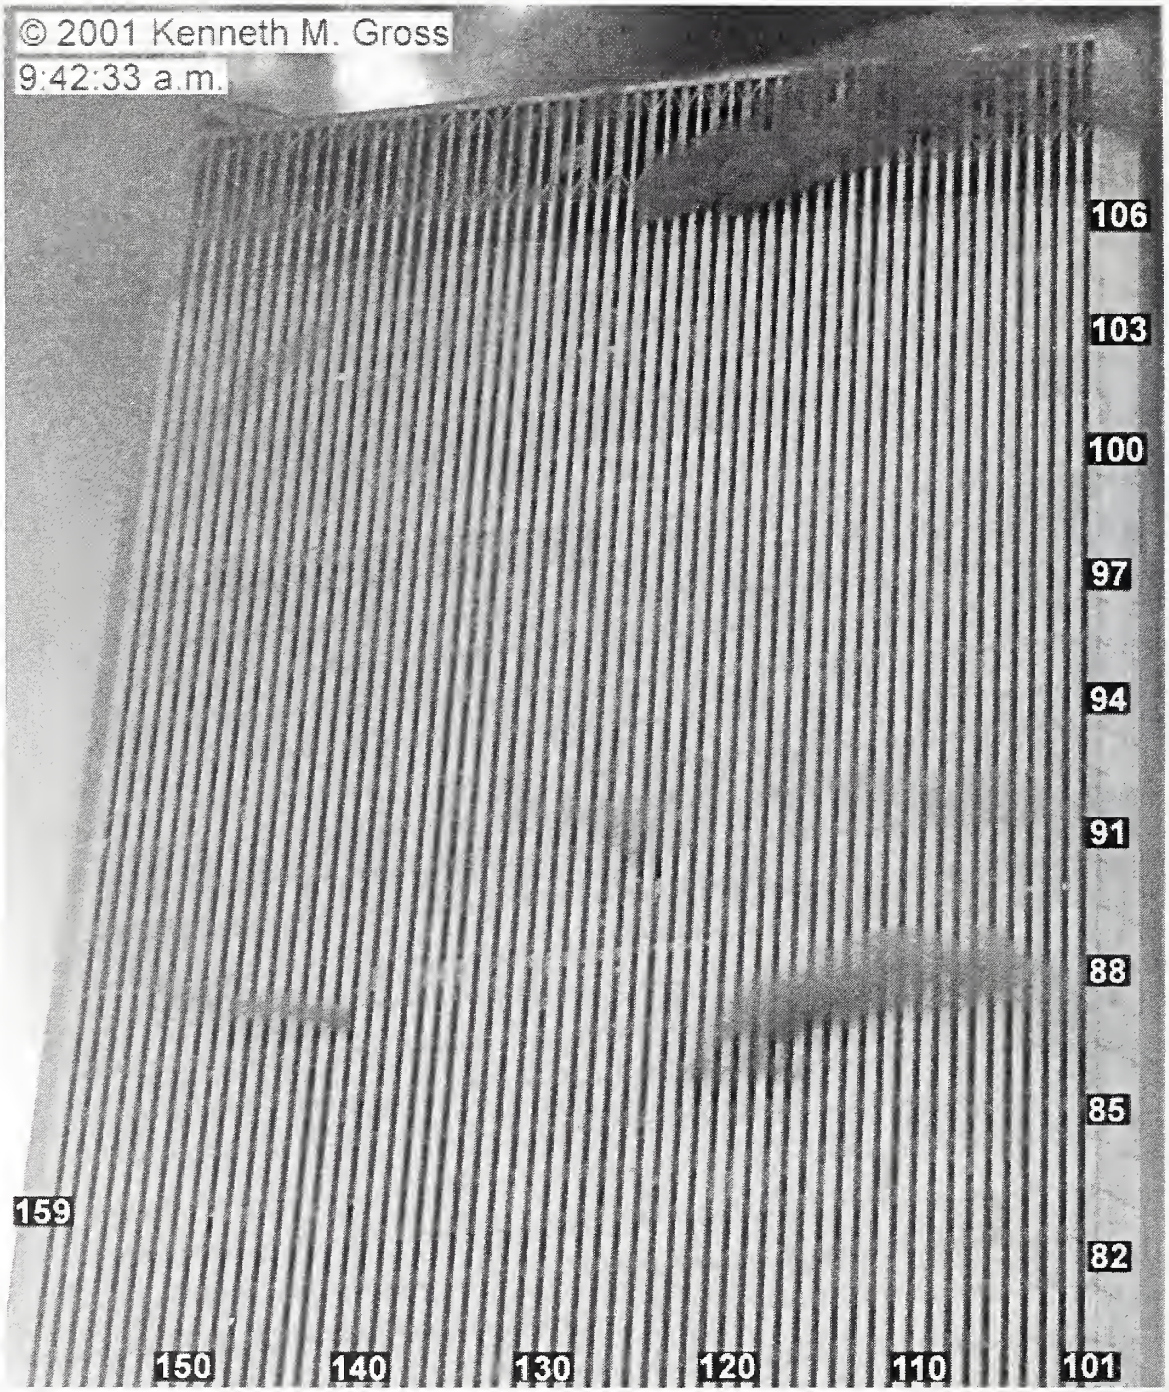
A clear view of the west face of WTC 2 at 9:42:33 a.m. is shown in Figure 9–57. Smoke is visible coming from several windows on the 86th, 88th, 91st, 105th, and 107th floors, as well as from the mechanical equipment room on the 108th and 109th floors. These locations include windows 86-117 to 86-122, 88-142, 91-125 and 91-126, 105-148, 107-123 to 107-129, and the two right-most windows on the 108th floor. Smoke was observed coming from these same locations at 9:34:19 a.m. (see Figure 9–42), with the exception of the windows on the 91st and 105th floors. These two locations had light smoke flows, and it is difficult to determine when the windows were opened.

In Figure 9–42 smoke was also coming from a window, 84-149, on the 84th floor. Smoke is not visible at this location in Figure 9–57, but the image has sufficient resolution to confirm that this window was open. Windows 84-141 and 84-127 also appear to be open on this floor. It is interesting that no smoke seems to be flowing from the open windows that are located closest to the fire floors. No other open windows are apparent on lower floors (note that the image from which Figure 9–57 was cropped extended as far down as the mechanical equipment room on the 76th floor).

On several floors electric lights are visible through windows on the west face in Figure 9–57. These include the 104th floor. The fact that lights remained on for floors well above the aircraft impact floors means that the aircraft did not cut all of the power lines running to the top of the tower as it passed through the core.

Figure 9-57. This cropped photograph shows the west face of WTC 2 at 9:42:33 a.m. It has been rotated and enhanced by adjusting the intensity levels. Column and floor numbers have been added.

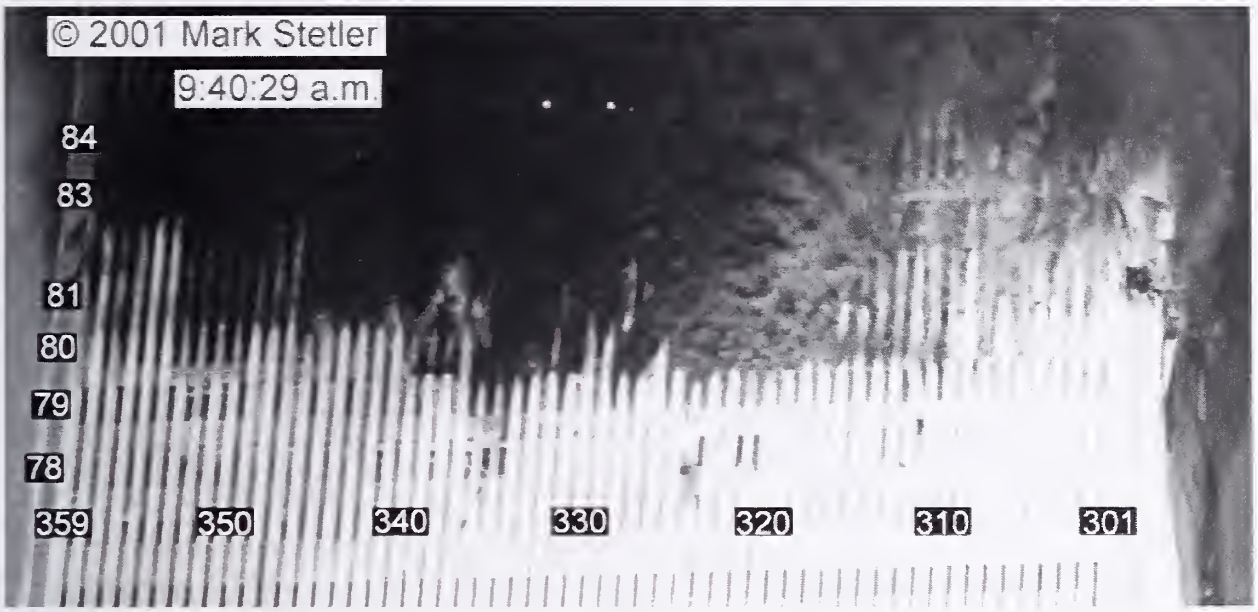
Fires are visible in Figure 9–58 on the 79th and 80th floors at roughly the same locations as in the photograph shown in Figure 9–43 and Figure 9–44, which was taken at 9:36:14 a.m. The fires are particularly heavy on the 80th floor near windows 80-331 to 80-339. The duration (roughly 50 s) of the heavy smoke flows and fires is comparable to that of the earlier event observed between 9:35:45 a.m. and 9:36:50 a.m. This suggests that the cause for the short-lived burning is the same. Therefore it is also tentatively attributed to the burning of a pool of aviation fuel somewhere inside the tower.

Figure 9-58. This cropped photograph showing the east face of WTC 2 was taken at 9:40:29 a.m. Column and floor numbers have been added.

A similar increase in smoke and fire was seen at roughly the same locations between 9:41:17 a.m. and 9:42:27 a.m. The duration and appearance were similar to the two earlier events. It is also tentatively attributed to the burning of an isolated pool of aviation fuel.

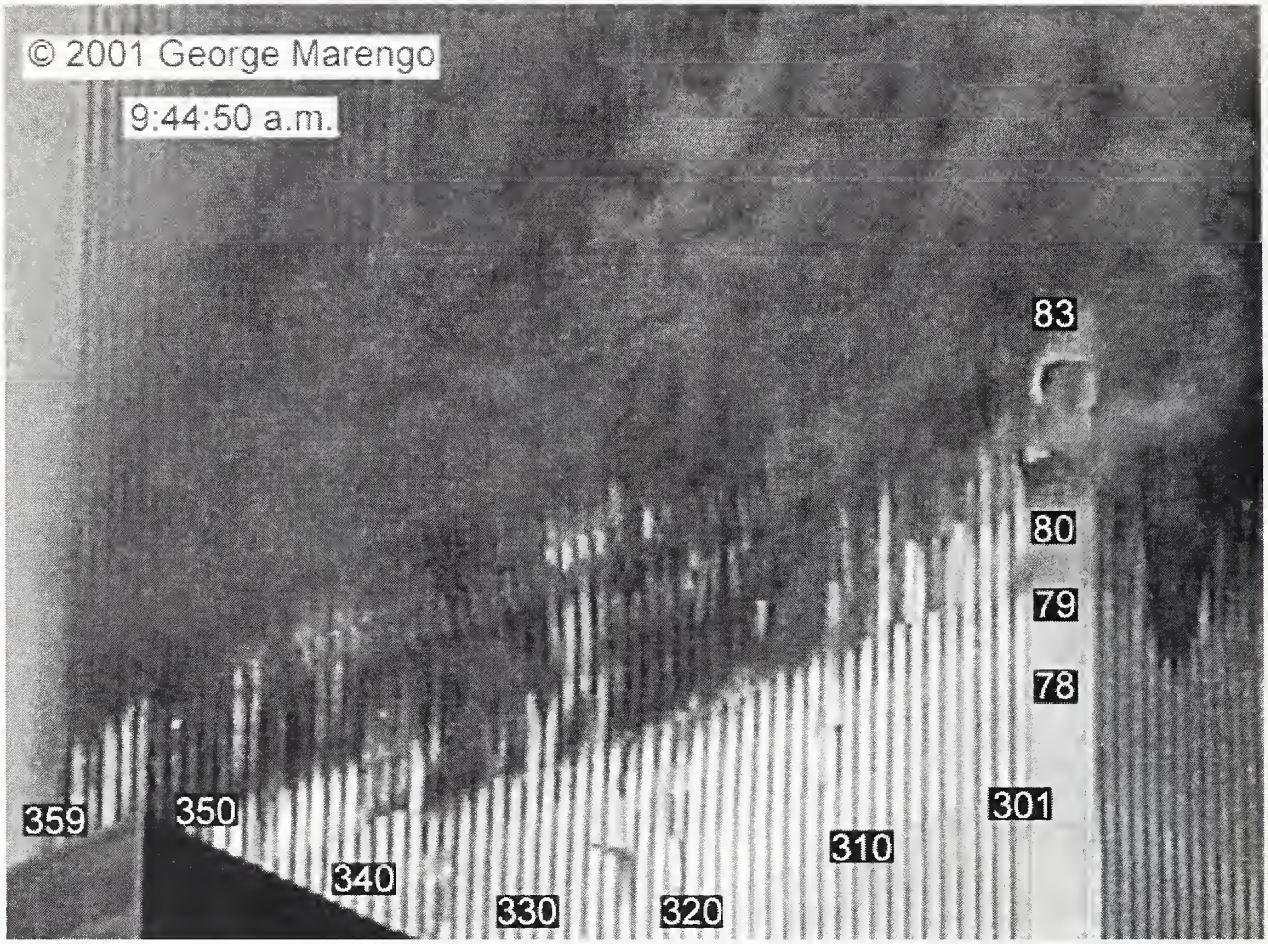
During the periods when the heavy smoke and fires were not present on the east face, its appearance was similar to that seen in Figure 9–48. Occasionally, coordinated puffs of smoke similar to those described earlier were observed coming from windows on the face. Figure 9–59 shows the east face at 9:44:50 a.m. in a photograph shot from the northeast. The amount of smoke coming from lower floors is light, and most of the face is visible. From this angle very little fire is evident, indicating that flames have receded back into the building or died down at many locations on the face. In particular, the heavy flames present near the center of the face in Figure 9–46 and Figure 9–48 seem to have died down by this time. There is evidence for a fire burning on the 82nd floor near the northern edge of the face. Fire had been observed here earlier. The fire in the northeast corner of the 81st floor continued to burn vigorously at 9:44:50 a.m. The bright flame attributed to metal combustion is still evident, but has markedly decreased in intensity.

In Figure 9–59 the columns near the center of the east face on the 80th and 81st floors appear to be bowing inward. A similar feature was identified earlier in Figure 9–46. This photograph provides additional visual evidence that the bowing was actually taking place and for its extent.

Figure 9-59. This cropped photograph was shot from the northeast and shows the east face of WTC 2 at 9:44:50 a.m. The original intensity levels have been adjusted, and column and floor numbers have been added.

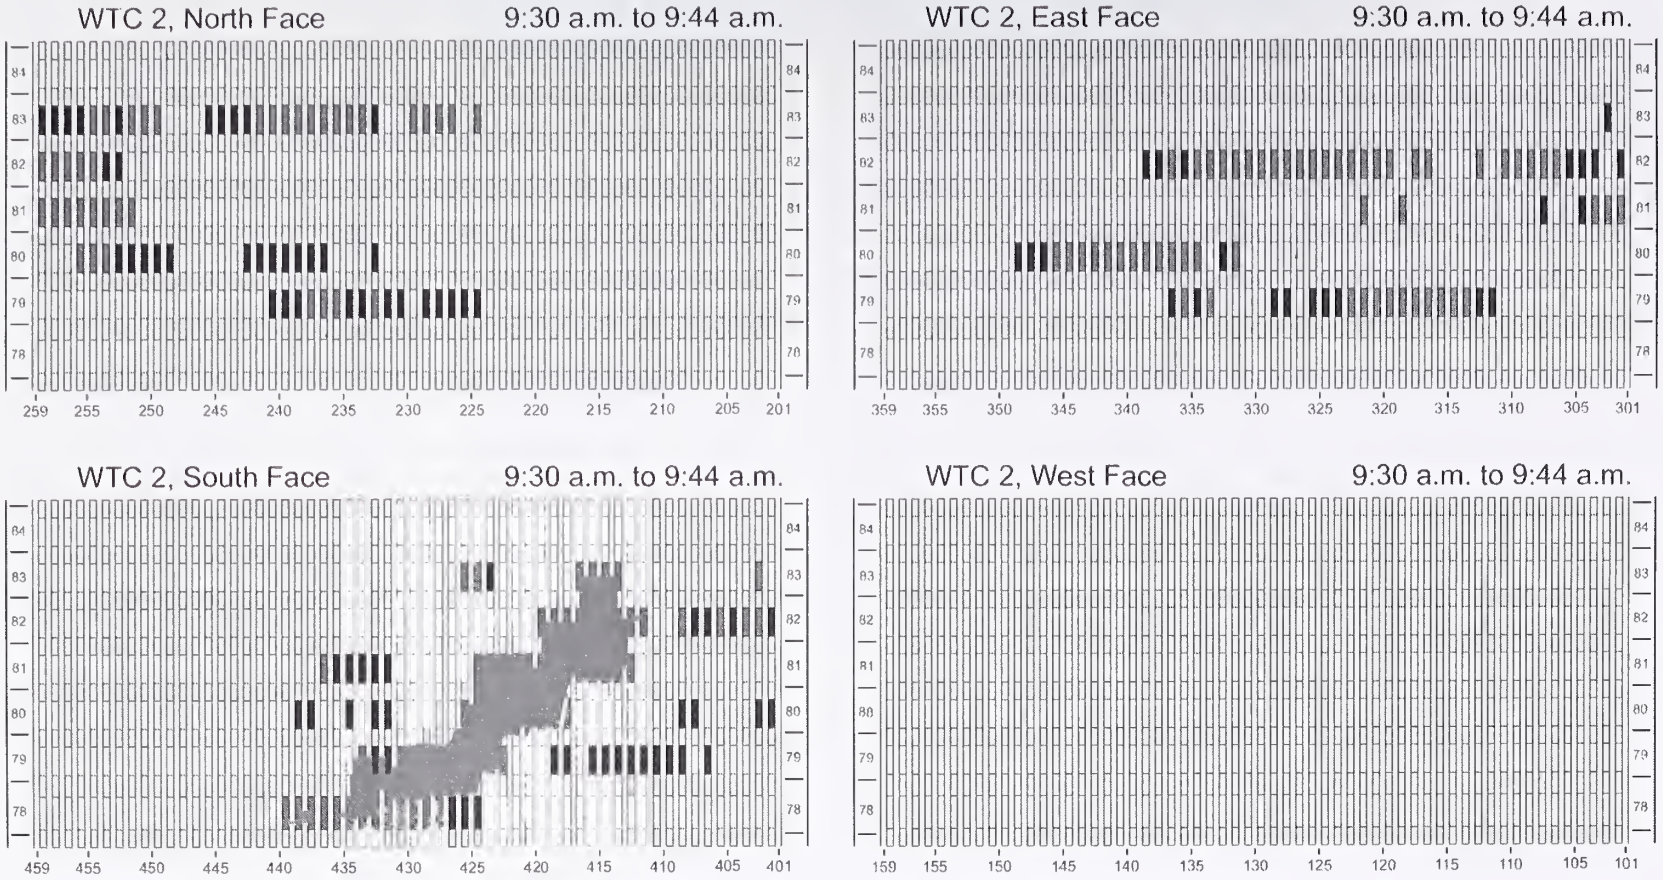
The fire behaviors and changes in distribution are more easily followed by comparing Figure 9–60, which shows integrated fire intensity maps for the four faces of WTC 2 during the period, with the corresponding maps for the period from 9:15 a.m. to 9:29 a.m. shown in Figure 9–34.

Figure 9-60. Maps of integrated fire observations between 9:30 a.m. and 9:45 a.m. are shown for the four faces of WTC 2. Colors represent the highest intensity fire observed in a window using the color scale defined in Figure 5-1.

Fires on the north face that were ignited on piles of debris on the 79th, 81st, and 82nd floors shortly after the aircraft impact, along with a fire that grew somewhat later on a debris pile on the 80th floor continued to burn throughout the period. At 9:29:15 a.m. a fire grew and spread rapidly on the 83rd floor just above the west side of the cold spot. During the period this fire spread to the west in two separate steps, reaching window 83-221 by 9:45:25 a.m. There was also evidence for westward fire spread on the 79th floor. Even though some small fires continued to burn at the periphery of the cold spot, the area continued to be mostly free of fire during the period. The fire behavior on the east face during this period was complex. In addition to the short periods of intense smoke release and burning on the 79th and 80th floors discussed above, a large fire with external flames burned for a short period on the 82nd floor near the center of the face. A fire on the northern edge of the 82nd floor, that had apparently died down earlier, reappeared. The 81st floor fire burning near and in the northeast corner continued to burn throughout the period. An unusually bright flame was observed in the corner that was attributed to metal combustion.

On the south face several fires on various floors around the aircraft impact cavity died down. A small fire was observed on the 83rd floor above the aircraft impact area. A new region of fire, as indicated by the presence of smoke and flame in windows 80-401 to 80-408, burned briefly on the eastern side of the 80th floor. A fire that had first appeared on the 79th floor to the east of the impact cavity around 9:15 a.m. continued to spread toward the east.

There were no indications of fire reaching the west face during the period. Smoke flow from additional open windows above the fire floors was observed and, as for earlier times, possibly caused by people breaking out the glass.

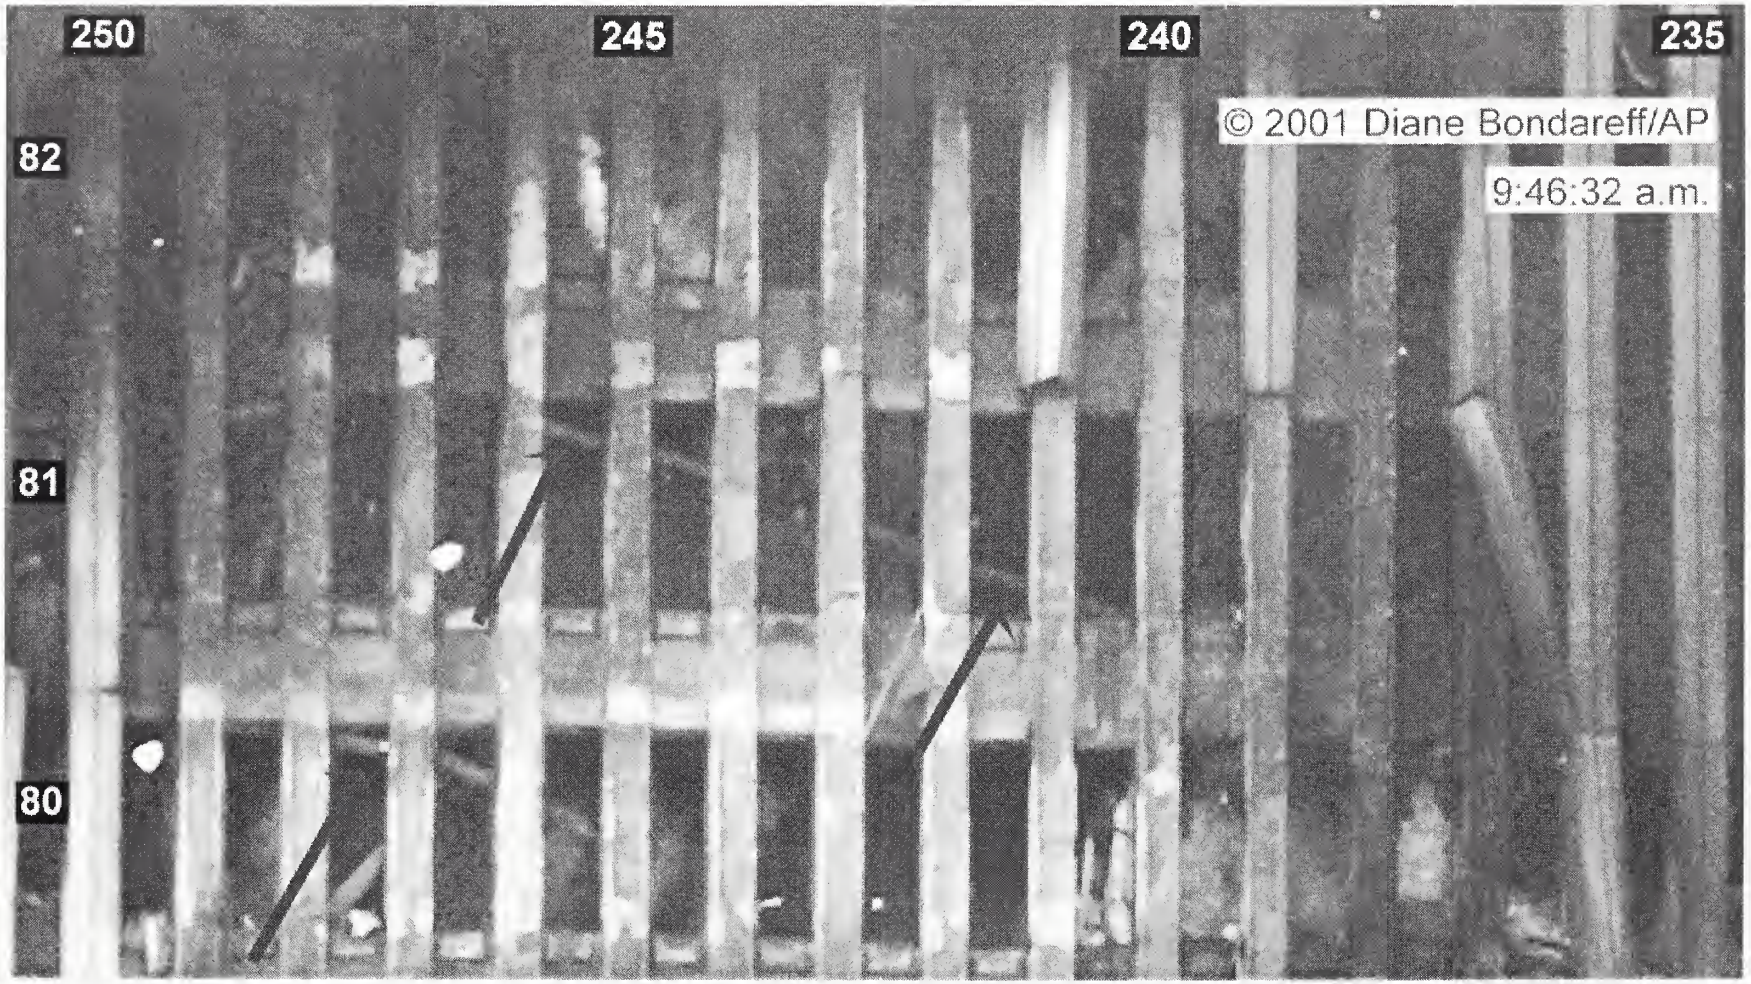
Closer inspection of Figure 9–62 shows that small dull-colored flames are visible on the 81st floor through windows 81-243 and 81-244 at the level of and above the hanging object. This suggests that a fire is burning on top of the object. It is possible that this fire is burning at the base of a debris pile that is also providing fuel for the fire visible immediately above on the 82nd floor. If true, this means that the hanging object is most likely a portion of the 82nd floor that has broken away from the spandrel at the base of the 82nd floor and settled to its current location from above.

The hanging object visible in Figure 9–62 on the 80th floor is also in the same position as observed at 9:42:31 a.m. In this closer view it has a very similar appearance to the hanging object on the 81st floor. Therefore, it appears to be a portion of the 81st floor slab that has separated from the spandrel and dropped down from above.

The fire that had been burning at the lower left-hand corner of the cold spot since before 9:15 a.m. is still burning vigorously in Figure 9–62. This long burning time suggests that the fuel is a large debris pile since typical office fuels should have burned out by this time. It may be that the 80th floor slab is missing in this area and that the fires visible on the 79th and 80th floors (see Figure 9–61) are actually burning on the same pile of debris. There is weak evidence to support such a conclusion. The arrows in Figure 9–63 have been added to highlight what may be a hanging object in windows 79-229 to 79-233 on the 79th

Figure 9-62. This image is enlarged from the photograph included in Figure 9–61 and shows the cold spot on the north face of WTC 2 at 9:46:32 a.m. The intensities have been adjusted to enhance dark areas, and column and floor numbers have been added. The arrows point to hanging objects visible on the 80th and 81st floors.

The contrast available in Figure 9–62 and Figure 9–63 is sufficient to identify whether or not glass has been broken out of windows. In Figure 9–62 the only window that is closed is window 81-235. In Figure 9–63 several windows are visible on the 79th floor in which glass has been partially removed, presumably due to heating from the nearby fire. The westernmost of these is window 79-220. A small spot fire is visible at the base of this window. On the 80th floor the westernmost open window is window 80-232. A small fire is also present in this window. The glass in the window to the immediate left, window 80-233, appears to be intact. Several open windows are visible on the 78th floor. These have been previously identified as having been broken during the aircraft impact and subsequent fireballs.

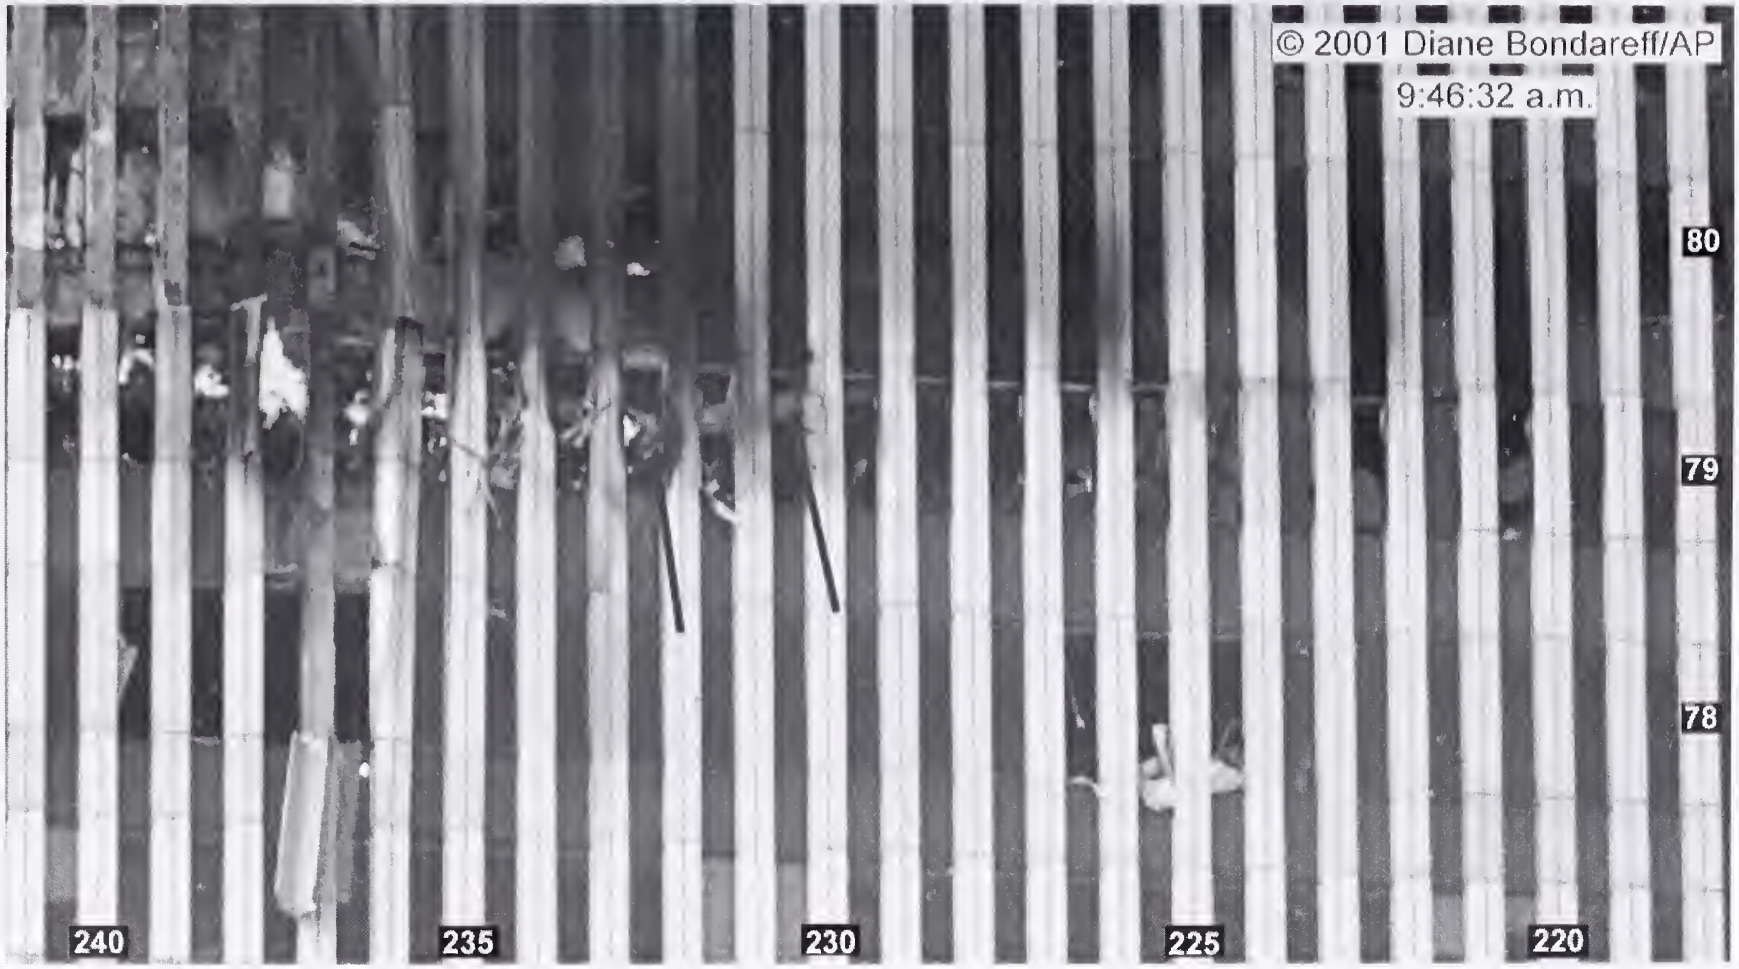
Figure 9-63. This image is enlarged from the photograph included in Figure 9–61 and shows fires near the center of the north face of WTC 2. The intensities have been adjusted to enhance dark areas, and column and floor numbers have been added. The arrows point to a hanging object visible on the 79th floor.

floor. The appearance of the object in these windows is somewhat different than those observed elsewhere on the north and east faces of WTC 2. This introduces some uncertainty into its identification as one of the hanging objects.

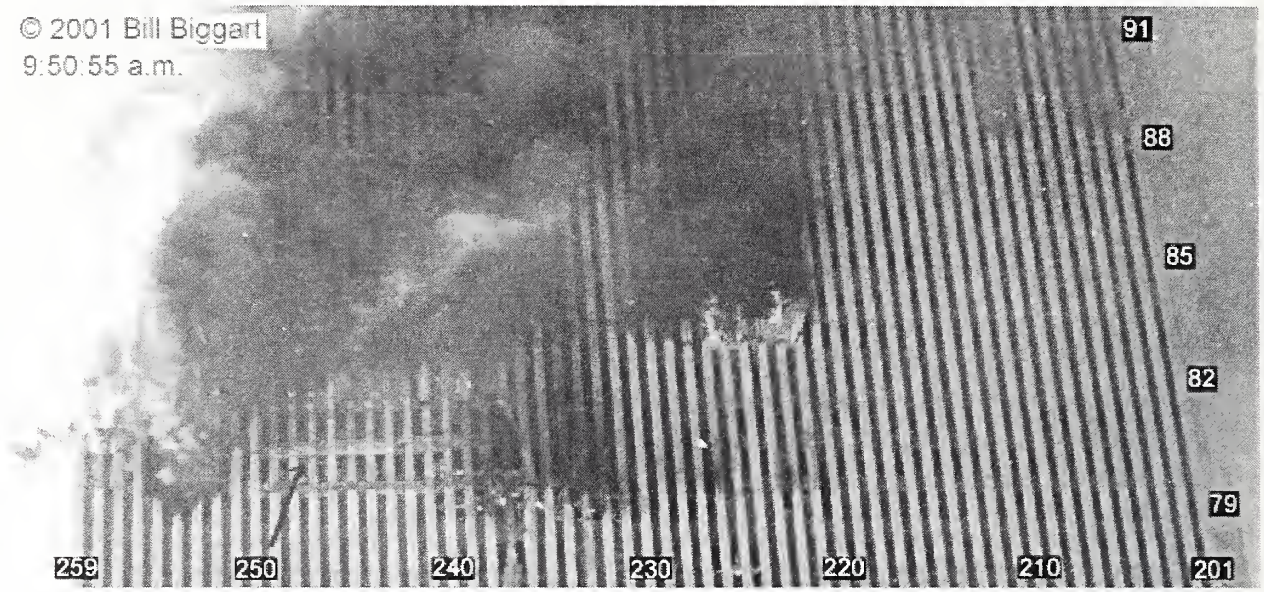
An image of the north face of WTC 2 taken at 9:50:55 a.m. is shown in Figure 9–65. Comparison with Figure 9–61 shows that some changes occurred in the approximately 4½ min between the two photographs. The intense fire burning on the 83rd floor moved west one window. A video shows that fire appeared in window 83-225 at 9:49:11 a.m.

The fire that was visible in the cold spot in the earlier photograph on the 82nd floor has spread over more windows. It is now visible in windows 82-247 to 82-244. The small flames observed earlier one floor down in window 81-243 are still visible, but a more substantial fire has grown just to the west, and flames are now visible in windows 81-239 and 81-240. The fire on the west side of the cold spot on the 80th floor has died down somewhat.

The fire on the eastern edge of the 81st floor seen in Figure 9–65 continues to burn on the debris pile in this area. The appearance of the fire that had earlier spread west on the 79th floor has not changed markedly. Earlier it was mentioned that windows on the 89th floor possibly had been broken open by people at windows 89-201 to 89-203 and window 89-208. Light smoke flows are visible coming from these windows in Figure 9–65.

The hanging object on the 80th floor is just visible in this photograph as indicated by the arrow.

Figure 9-65. This cropped photograph shows the north face of WTC 2 at 9:50:55 a.m. The original has been rotated and enhanced by adjusting the intensity levels. Column and floor numbers have been added. The arrow points to a ganging object visible through open windows on the 80th floor.

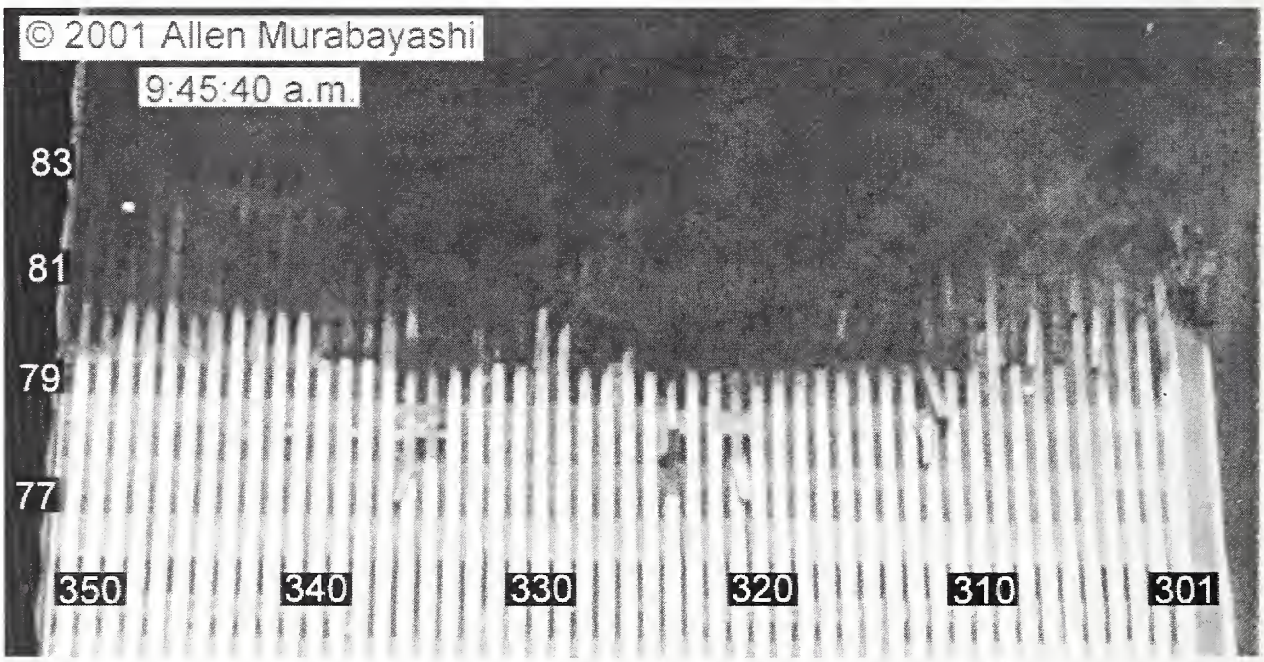
Starting around 9:44:58 a.m. there was another period during which heavy smoke flows came from numerous open windows on the 79th and 80th floors of the east face. This release lasted until approximately 9:46:05 a.m. Figure 9–66 shows an image recorded during this smoke release at 9:45:40 a.m. Comparison with Figure 9–43 and Figure 9–58 indicates that the amount of smoke flow and visible flame are much less than observed during the three similar earlier events. Nonetheless, the smoke flow obscured much of the face, and videos show that intermittent flames appeared outside of some windows. Near the end of this smoke release episode, there were two large pressure pulses at 9:45:57 a.m. and 9:46:01 a.m. that pushed large amounts of smoke out of windows on the 79th and 80th floors.

In Fig. 9–66 flames are visible on the 79th floor between windows 79-313 and 79-319 and are coming from window 82-306 to window 82-308 on the 82nd floor. At 9:38:22 a.m. (see Fig. 9–48) fires were observed at the same locations. The earlier photograph was shot in between the periods of heavy smoke flow and external flaming. This shows that these fires are well established and are not associated with the periods of heavy smoke flows and external burning. The fire in the 81st floor northeast corner continued to burn at 9:45:40 a.m.

Figure 9-66. This cropped photograph shows the east face of WTC 2 at 9:45:40 a.m. The image has been rotated, and the intensity range has been adjusted. Column and floor numbers have been added.

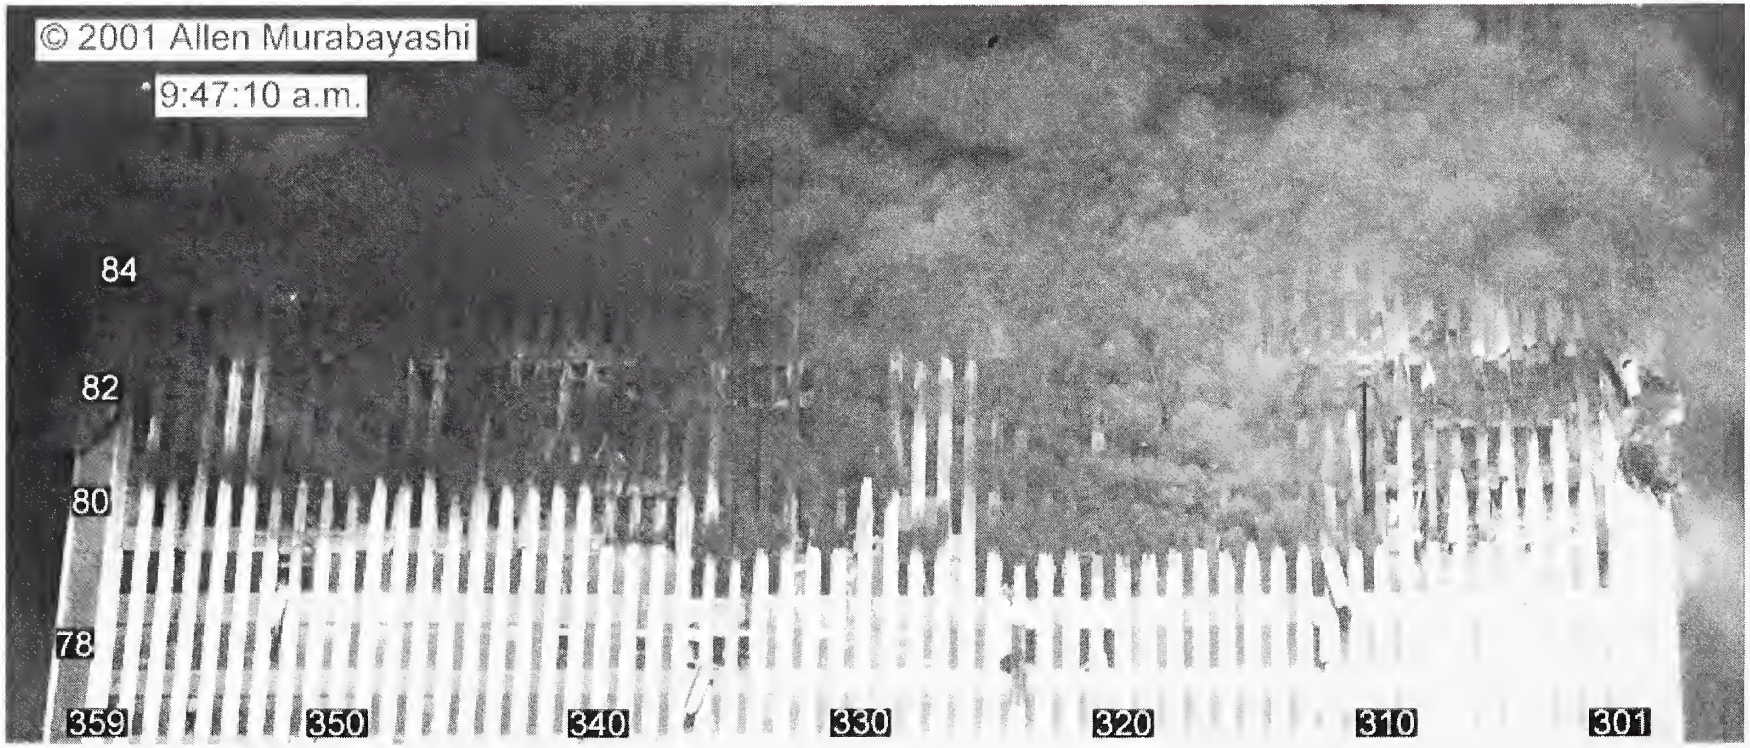
Figure 9–67 shows a higher resolution photograph of the east face taken 1½ min after Figure 9–66 at 9:47:10 a.m. The smoke has cleared up, and it is now possible to see many more windows at the south side of the face on the 80th and 81st floors, as well as higher up on the face. A substantial fire, visible in windows 79-313 to 79-320, continues to burn on the 79th floor. Flames are also present in windows 82-303 to 82-307. The fire on the 81st floor is isolated to the first couple of windows along the northern edge of the east face and the pile of debris in the northeast corner. At this time flames were not visible elsewhere on the east face.

Figure 9–68 shows a view of the south face recorded at 9:52:00 a.m. It is taken from a video shot from a location to the southeast of the tower. Several small fires are visible on the 78th (window 78-418), 79th (window 79-408), 80th (windows 80-438 and 80-439), and 81st (window 81-436) floors. Heavy smoke is flowing from windows near the eastern edge of the 80th floor. There is a stream of smoke coming from the 81st floor in the same area. At this time the smoke flow from other areas of the face was relatively light. Markings on column covers near the tops of windows indicate that smoke had earlier come from windows on the 79th, 80th, and 81st floors just to the west of the aircraft impact cavity. The smoke band on the 81st floor, which extends from window 81-431 to 81-439, is the darkest. The presence of this smoke band is consistent with the recent smoke releases observed from this floor.

Figure 9-67. This cropped photograph of the east face of WTC 2 was taken at 9:47:10 a.m. The original has been rotated slightly, and the intensity levels have been adjusted. Column and floor numbers have been added. The arrows highlight a hanging object that is visible through open windows on the 82nd floor.

Figure 9-68. This view of the south face of WTC 2 was taken from a video recorded at 9:52:00 a.m. The intensity levels have been adjusted, and column and floor numbers have been added.

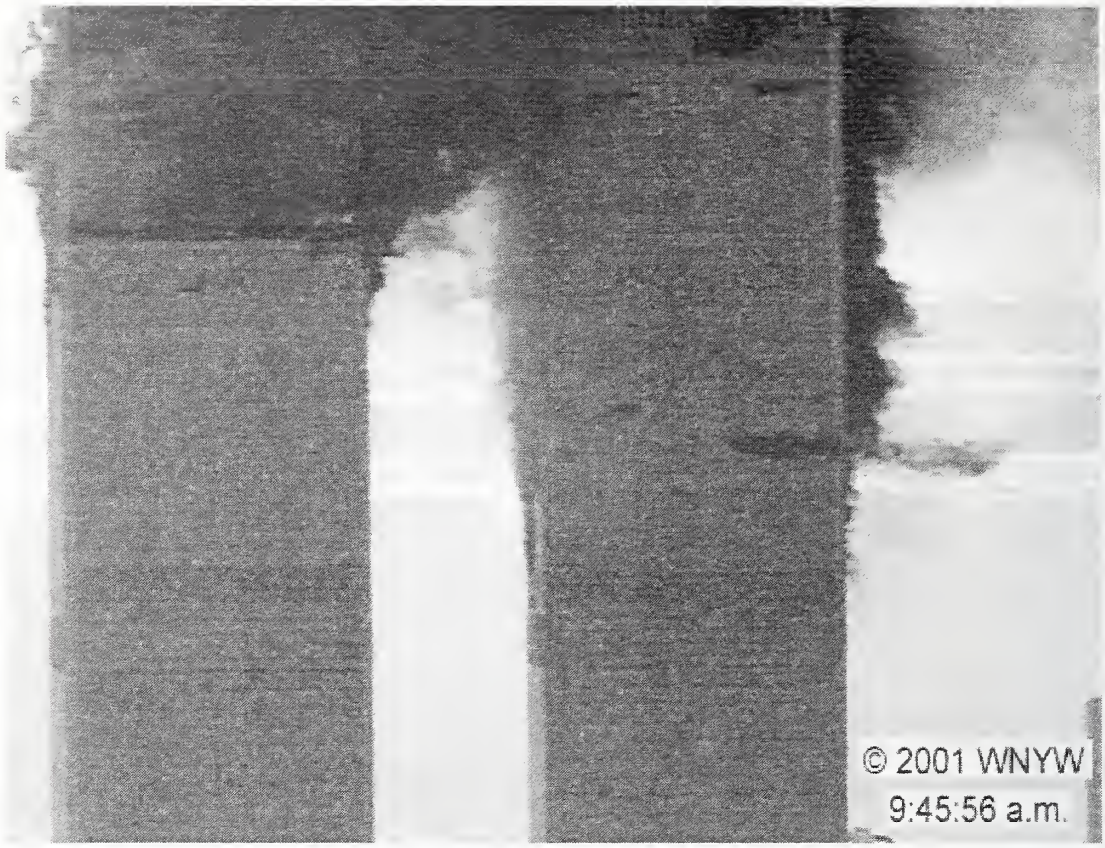
Figure 9–69 shows a long-distance view of the west face of WTC 2 at 9:45:56 a.m. Smoke streams are coming from open windows on several floors, many at the same locations observed in earlier images. The discussion associated with Figure 9–57 refers to open windows on the 84th, 86th, 88th, 91st, 105th, and 107th floors. The three lower smoke trails visible in Figure 9–69 are coming from the windows previously identified on the 86th, 88th, and 91st floor. Closer to the top of the face, three separate smoke trails are visible on the 95th floor. Slightly closer views of the area show that the northern most stream is coming from window 105-148, which is the location visible in Figure 9–57. The other two streams are from near windows 105-116 and 105-140. These two smoke flows were observed to be intermittent in videos of the west face. They were detected briefly as early as 9:43:45 a.m. The heavy smoke flow from the 107th floor observed earlier is prominent in Figure 9–69. The light smoke coming from the southern edge of the mechanical equipment room on the 108th floor is also visible.

Figure 9-69. This west view of WTC 1 and WTC 2 is a frame captured from a news helicopter video at 9:45:56 a.m. The intensity range has been adjusted.

Figure 9–69 provides an indication of the complexity of the wind patterns present on the west face of WTC 2 on September 11, 2001. The smoke trails on the lower floors are flowing in opposite directions. Around this time, the heavy smoke coming from windows on the 86th floor was observed streaming across the south face of the tower. A similar flow pattern is evident in Figure 9–57. Videos show that at other times the smoke from these windows would reverse direction and actually flow toward the north. Figure 9–42 shows an example of this flow at 9:34:19 a.m. As discussed in Section 4.1, these complex wind patterns developed because WTC 2 was on the leeward side of WTC 1, which shielded it from the direct impact of the ambient wind and created complex flow patterns that interacted with WTC 2.

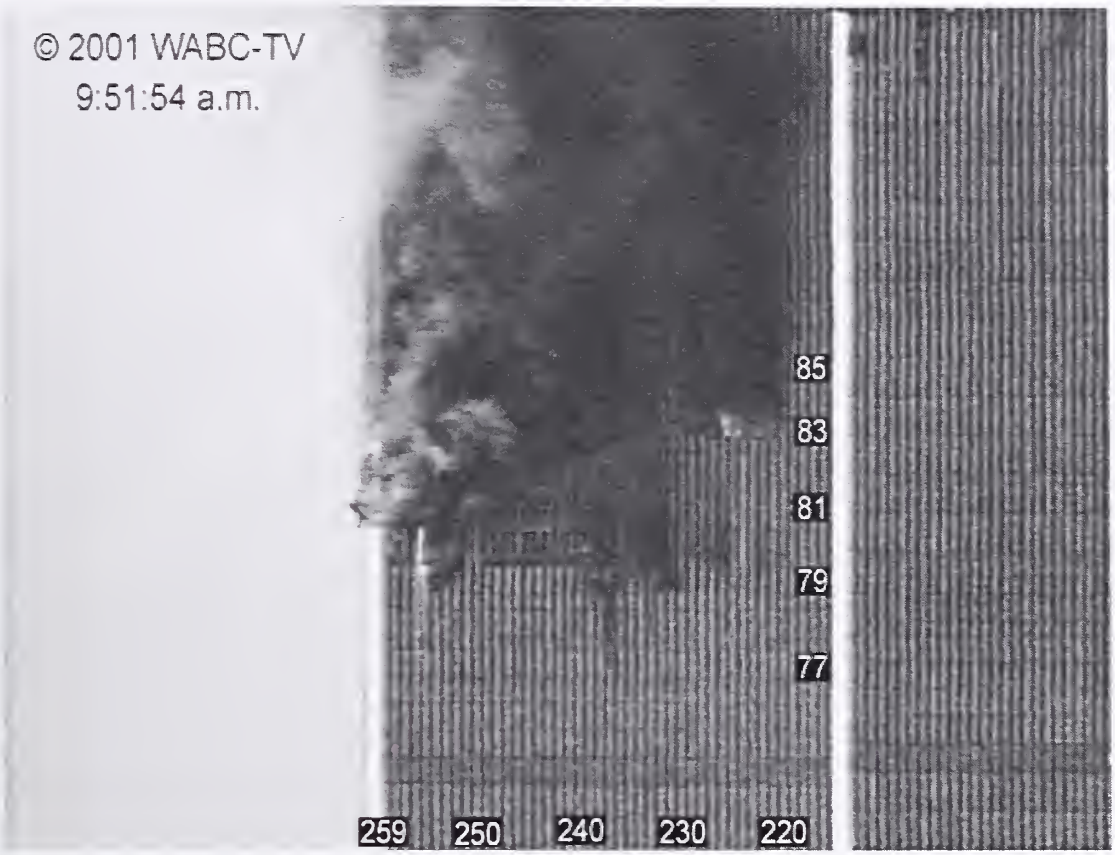
At 9:51:51 a.m. puffs of smoke and/or dust were expelled from open windows on the 79th, 80th, and 81st floors on the north face of WTC 2 near the east edge. These included windows 79-253 and 79-254, 80-257 and 80-258, and 81-254. Almost simultaneously, smoke was pushed from windows on the 79th and 80th floors of the east face. Just over a second later, a bright spot appeared at the top of one window, 80-255, on the 80th floor, and a glowing liquid began to pour from this location. As it fell, the glowing liquid struck the base of window 80-255 and splashed before falling further. Figure 9–70 shows a frame captured from a video at 9:51:54 a.m. in which the falling liquid and the splashing can be seen. This liquid flow lasted approximately 4 s before subsiding. After the flow stopped, the glowing spot was still visible at the top of window 80-255.

Figure 9-70. This image of the north faces of WTC 1 and WTC 2 was captured from a video recorded at 9:51:54 a.m. The intensity levels have been adjusted, and column and floor numbers have been added to WTC 2.

It has been reported in the FEMA report (McAllister 2002) as well as in the media that what appeared to be molten metal was observed pouring from the north face near the northeast corner prior to the collapse of WTC 2. This is the area where the sustained fires on the 81st and 82nd had been burning since the aircraft impact. The likely explanation for the observation of pouring liquid is that the material had originally pooled on the floor slab above, i.e., the 81st floor, and that it was allowed to pour out of the building when the floor slab in the immediate vicinity either pulled away from the spandrel or sank down to the point where the window was exposed. The puff of smoke and/or dust just prior to the first appearance of the molten material suggests that the ultimate event responsible for the release of the material occurred suddenly, in the process creating a pressure pulse that forced smoke and/or dust out of open windows over three floors.
